Pump Coupling Failures

DE Leader: T. Christian
DE Team Members: H. Zahlee, K. Nate, S. James, H. Roy

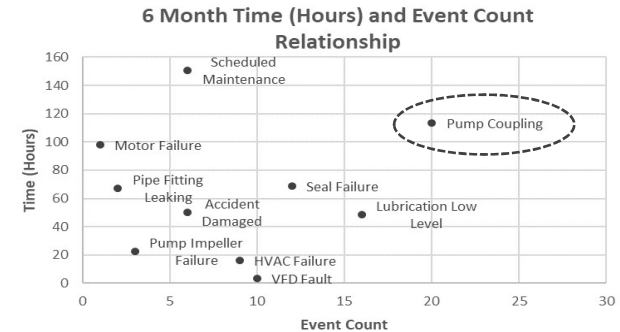
Pump Coupling failure has the highest event count and is the second highest contributor to downtime for the last 6 months.

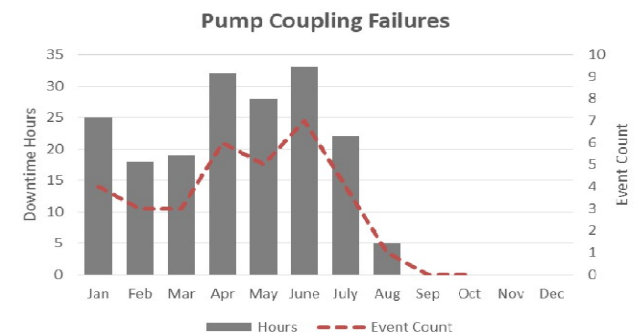
Since implementing the solutions in mid-August, there have been no coupling failures in pumps in the Milling area of the Flaxton plant. The team will look for opportunities to share and replicate the improvement in other rotating equipment with couplings throughout the business.
