Mixing Table Slides Replacement

DE Leader: M. Bowman
DE Team Members: L. Steelman, A. Buchanan, K. Benison

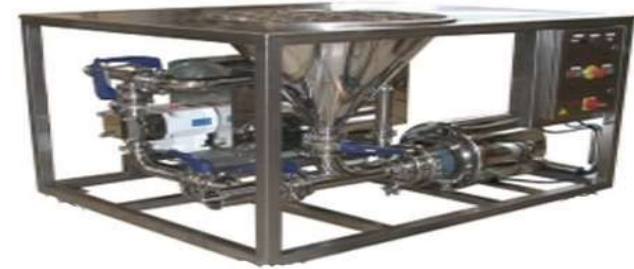
Defect History:

The maintenance team has identified that there are issues replacing the mixing table slides each time.
